Re: Notice of Violation Compliance Evaluation Inspection OHD987018207

### COMPLIANCE EVALUATION INSPECTION REPORT

Formed Fiber Technologies dba ConForm Automotive

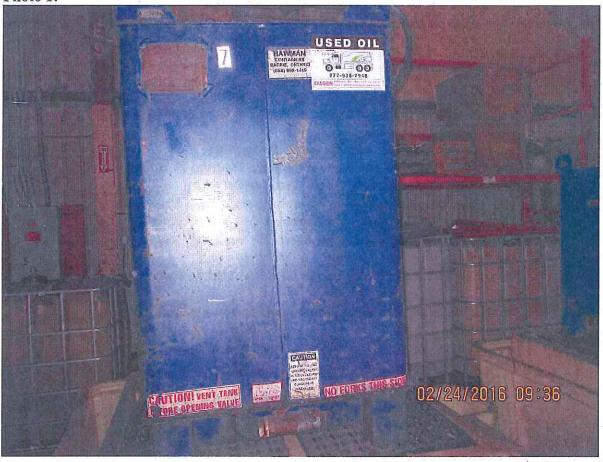
Photo 1:

CFA maintains its primary waste storage area on the north side of Building #1, which consists of a steel storage cage and other designated spaces around that cage. Outside the south end of the cage were four blue steel totes and five transparent plastic totes. Two of the four blue steel totes were accumulating used oil generated around CFA's site from molding operations. These two totes were labeled as "Used Oil" (See Photos 1 and 2 in Attachment A: Inspection Photographs). The two other blue steel totes were storing product lubricating oils (See Photo 3). The five transparent plastic totes were storing oily wastewater generated by CFA's operations. Mr. Wiley said the oily wastewater and used oil are managed as different waste streams by Heritage Crystal Clean when taken off-site. The material in the transparent plastic totes was mostly water with a visible layer of oil floating on top (See Photo 4).

Photo .	Description	Time (CST)
1	A tote of used oil in Building #1's waste storage area.	9:36 AM
2	A tote of used oil in the waste storage area. The used oil label is not visible in this photograph.	9:36 AM
3	Two totes of product oil near the waste storage area.	9:36 AM
4	One of several totes of oily wastewater in the Building #1 waste storage area. The oil layer is visible on top of the water.	9:38 AM
5	A 55-gallon drum of used oil in the waste storage cage. The drum to the right was later found to contain pig mats, and not used oil.	9:45 AM
6	The 55-gallon drum accumulating hazardous waste aerosol can liquids in the waste storage cage.	9:45 AM
7	The emissions control device on the 55-gallon drum in Photograph 6.	9:45 AM

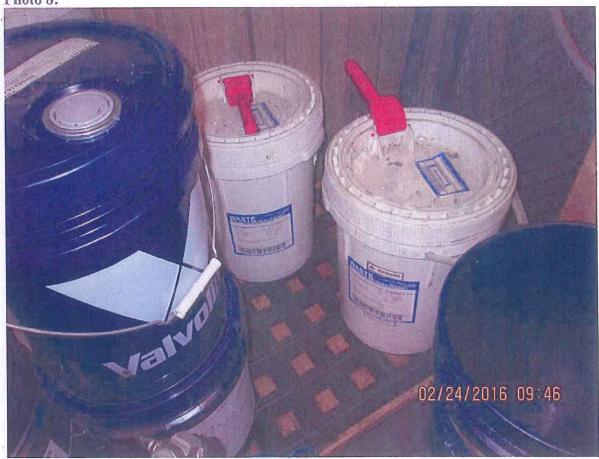
# Photo 8:

Inside the waste storage cage CFA was storing several drums and numerous buckets of product chemicals and lubricating oils. Two 55-gallon drums against the north wall appeared to be storing used oil. Only one of the drums was labeled as "Used Oil" (See Photo 5). To the left of the drum labeled as used oil was a drum accumulating waste aerosol can liquids (See Photo 6). The drum, dated 8-10-15, was equipped with a puncturer and an emission control device. The granular media inside the emission control device did not match the "Ready" or "Replace" color on the device's legend (See Photo 7). Mr. Wiley was unsure why this was the case. The drum was marked with a Heritage Crystal Clean "Non-RCRA or RCRA Exempt" label which contained CFA's generator information, a D001 waste code, and a "CESQG" designation. Ms. Altman clarified to Mr. Wiley that even if CFA is a CESQG (Conditionally Exempt Small Quantity Generator), Ohio law requires that the facility ensure its hazardous waste is sent to a permitted treatment facility, and that a label stating "RCRA Exempt" is not accurate. The storage cage also contained three buckets of universal waste batteries (See Photo 8). These buckets were labeled and dated 8-10-15.

8.	Two buckets accumulating universal waste batteries in the waste storage cage.	9:46 AM
9	Several boxes accumulating universal waste light bulbs near the waste storage cage.	9:52 AM

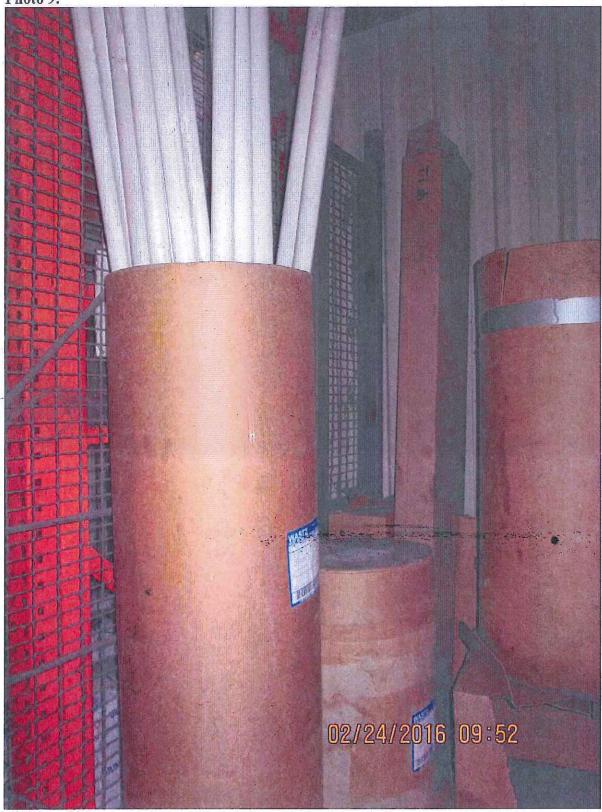
Photo 9:

Building #1. There were at least five boxes of universal waste lamps observed in the area during the inspection, only two of which were labeled as universal waste lamps. The three other boxes in the area were not visibly marked with one of the phrases above. CFA, therefore, violated the universal waste labeling requirement.

At the time of the inspection, CFA accumulated universal waste lamps near a waste storage cage on the north side of its Building #1. There were at least five boxes of universal waste lamps observed in the area during the inspection, one of which was open with waste lamps protruding from its top. CFA, therefore, failed to keep its containers of universal waste lamps closed and violated the storage requirement above.

Outside the entrance to the waste storage cage was small area accumulating universal waste light bulbs. There were approximately five boxes accumulating bulbs, two of which had visible labels. The other boxes present were not labeled, and one of the boxes was open with bulbs protruding from its top (See Photo 9). Ms. Altman and I briefly explained the universal waste management standards to Mr. Wiley.

On the same day of the inspection, February 24, 2016, CFA provided a follow-up email which contained photographs of the universal waste storage area. The photographs displayed all boxes of universal waste lamps as being properly labeled. Thus, no further action is necessary to comply with this requirement.

On the same day of the inspection, February 24, 2016, CFA provided a follow-up email which contained photographs of the universal waste storage area. The photographs displayed all boxes of universal waste lamps secured and closed as required. Thus, no further action is necessary to comply with this requirement.

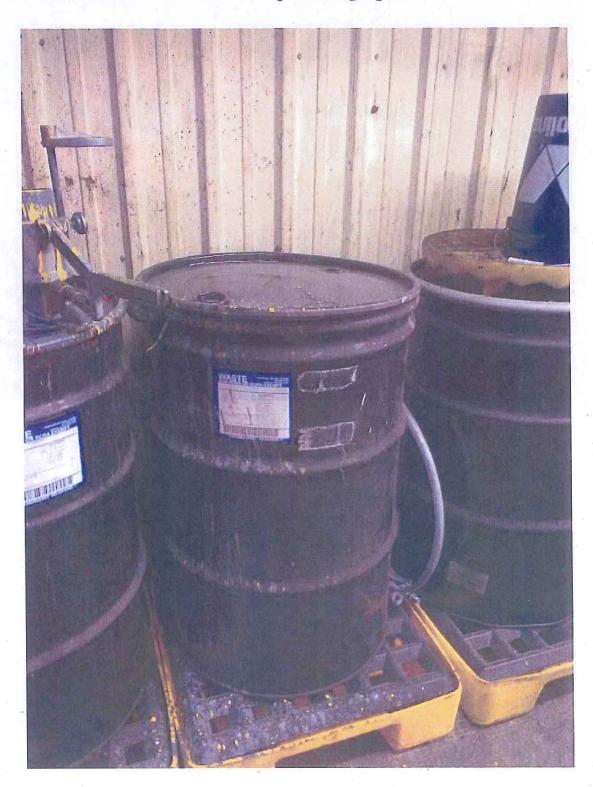
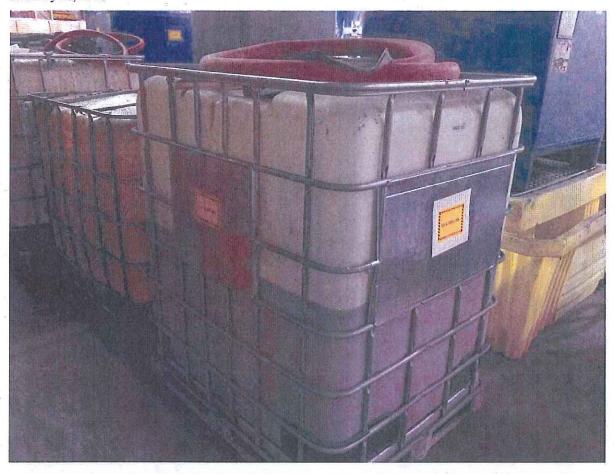
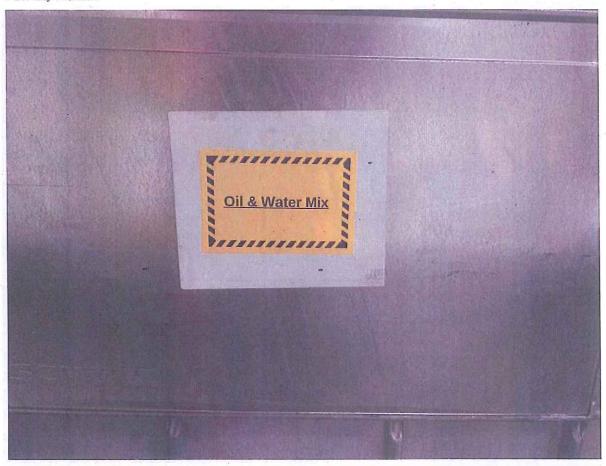
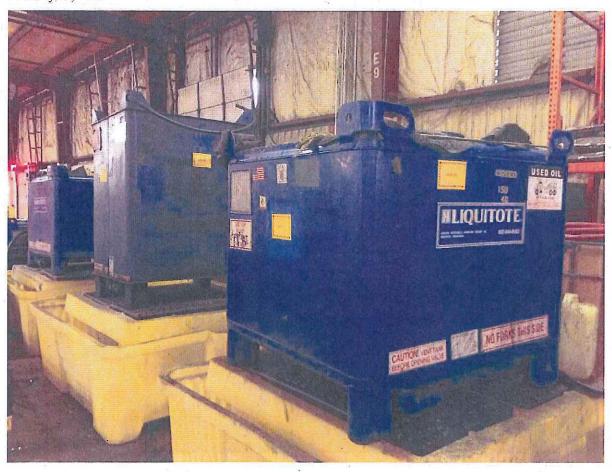
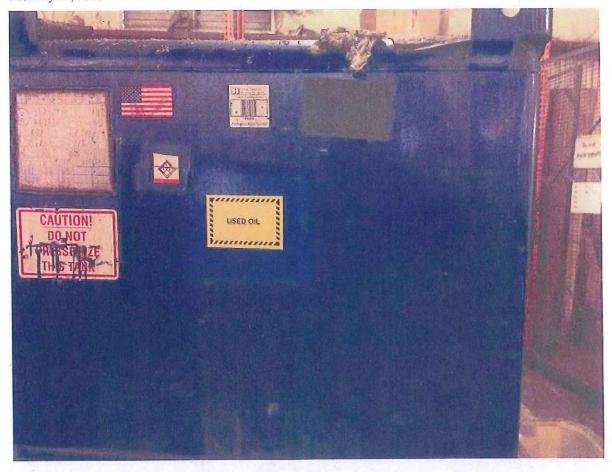
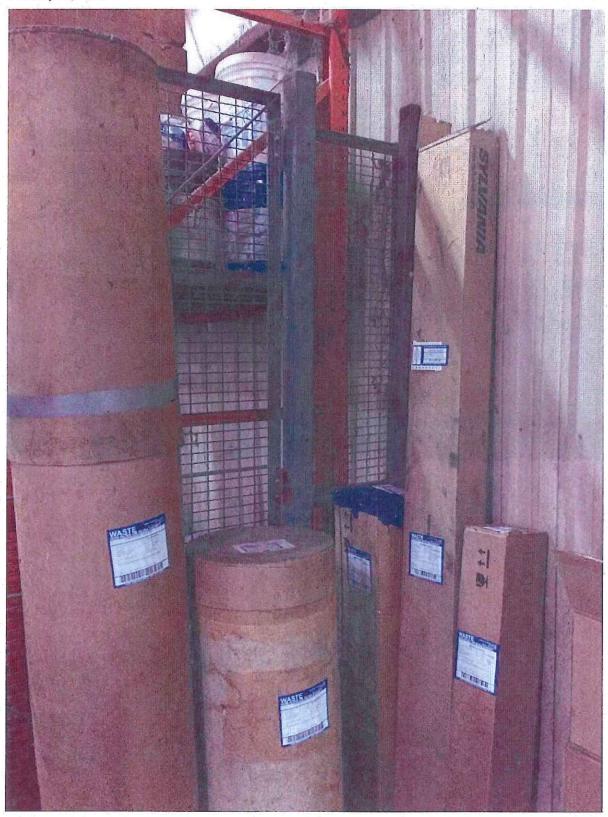
# ATTACHMENT C: Follow-Up Photographs

On the same day of the inspection, Mr. Wiley provided an email containing photographs of the universal waste light bulb storage area and other containers in the waste storage area in Building #1. The containers of universal waste bulbs had been labeled and closed. Mr. Wiley also stated the drum of used oil that was not labeled in the storage caged did not actually contain oil but rather compacted pig mats. These follow-up photographs are in Attachment C.
